**National Register of Historic Places
Registration Form**

historic name *Northerner Shipwreck (Schooner)*
other names/site number *47-OZ-194*

Northerner Shipwreck (Schooner)
Ozaukee County, Wisconsin

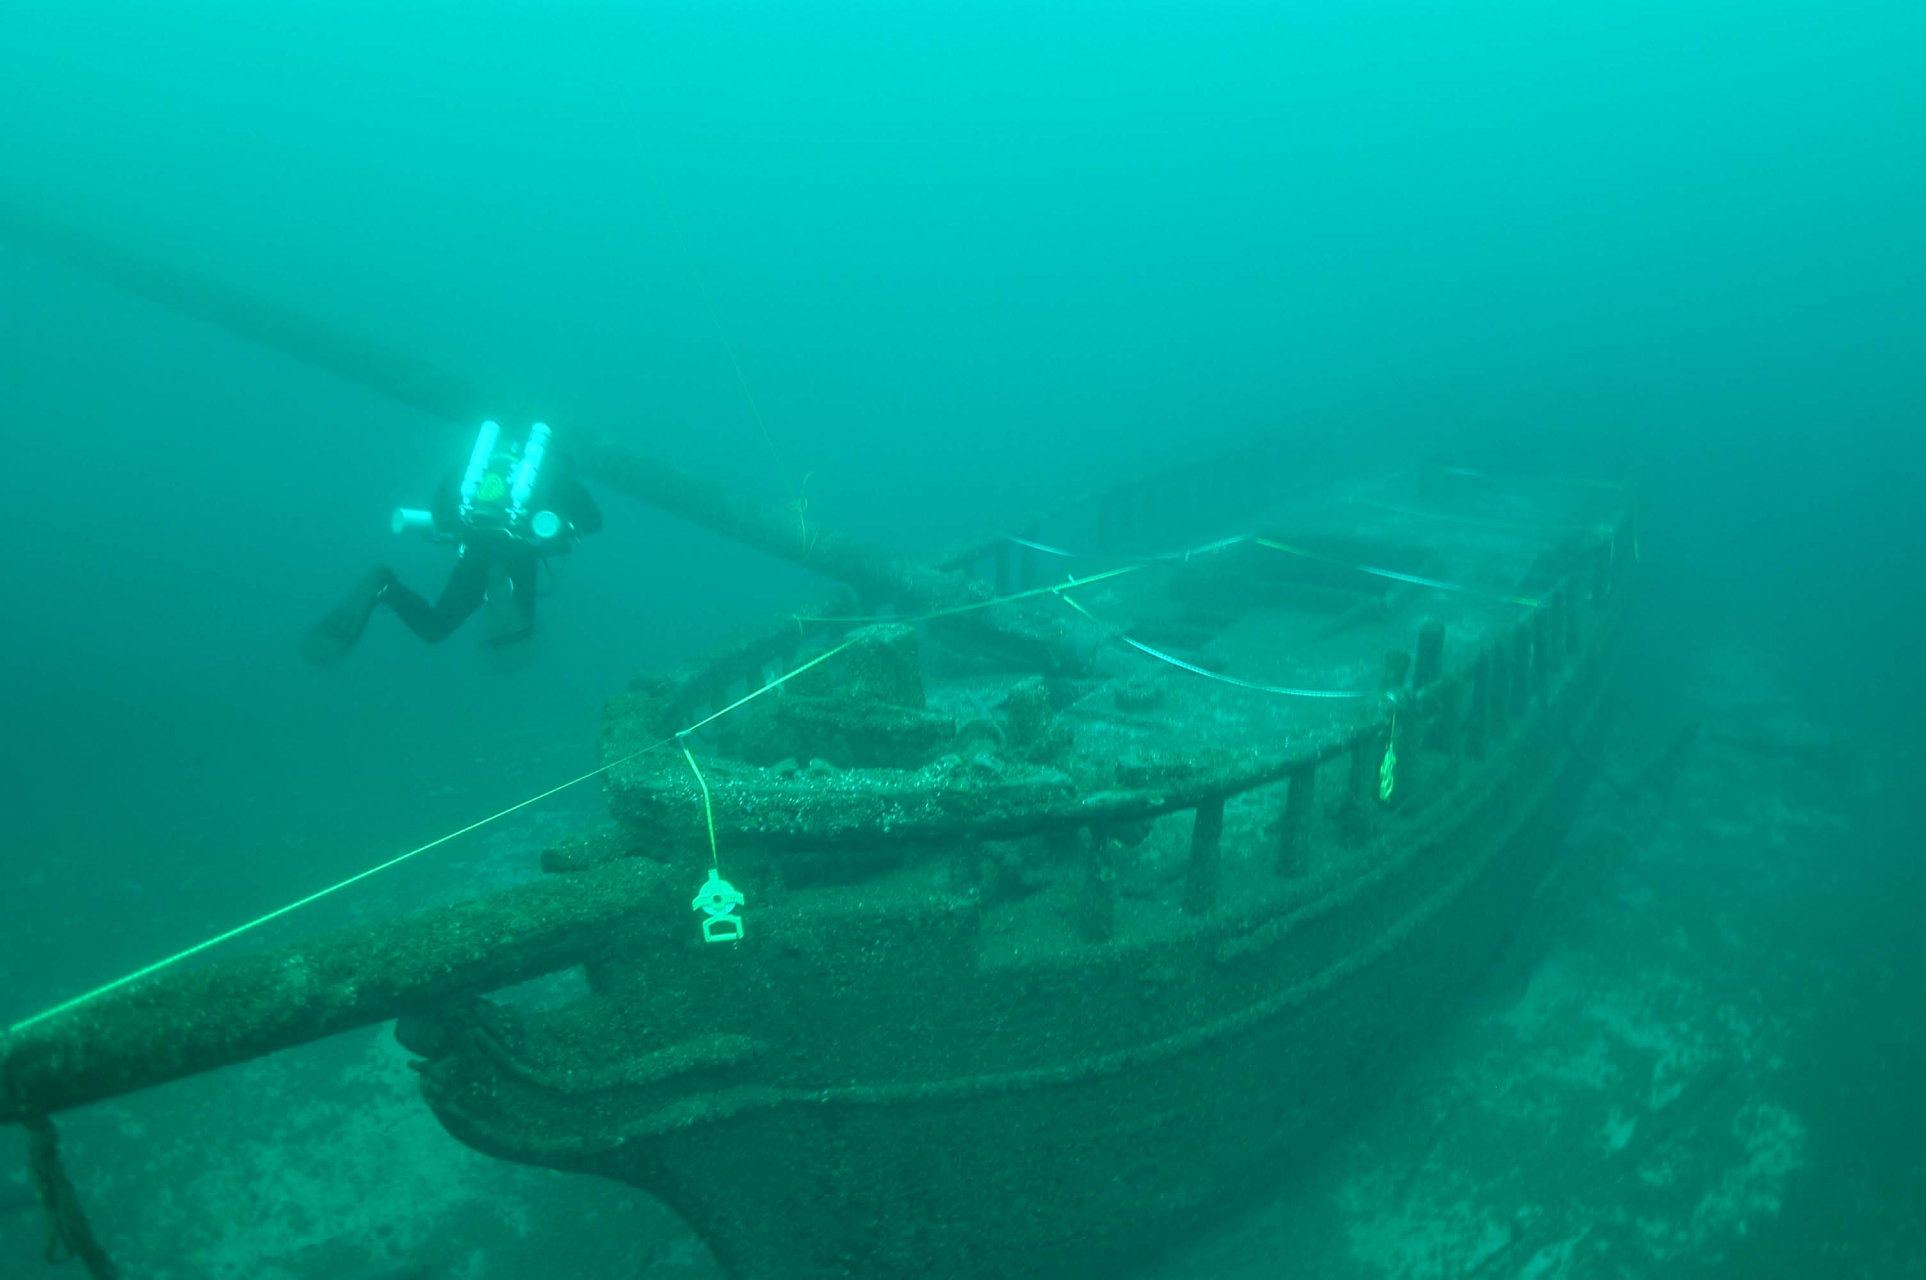
Photo #1 of 1

Northerner Shipwreck (Schooner)
Ozaukee County, Wisconsin
Photographer Tamara Thomsen
1 August 2009
View of bow looking aft

Major components of the vessel's standing rigging are extant, including the foremast, a topmast, bowsprit and jibboom. The jibboom, 32.2 feet in length, has been dislodged from atop the bowsprit and now lies on the lake bottom off the vessel's starboard bow. The bowsprit cap remains attached to the jibboom 8.5 feet from the jibboom's base. The tip of the bowsprit was broken away with the jibboom cap and remains affixed to the cap. An iron eye is fastened to the jibboom 25.7 feet from its base.

The bowsprit is stepped in the hull at an angle of 10.5 degrees. The bowsprit is octagonal in section from the base to the billethead, and is round in section from the billethead forward. The bowsprit was rigged with two chain bobstays that were tensioned with an iron turnbuckle fastened to the underside of the bowsprit, one of which remains attached near the bowsprit's tip. There are small strips of grey cotton cloth wrapped around the top of the turnbuckle – possibly chaffing gear that has been preserved by the impregnation of iron oxide from the turnbuckle. The lower ends of the bobstays were fastened to two iron eyes on the cutwater. A short section of the inner bobstay remains attached to the upper eye, but none of the outer bobstay is extant as the eye is broken on the cutwater.

The stem is .4 feet sided and reinforced by a stem iron that terminates one inch below the gripe's upper edge. The stem iron is highly corroded, precluding a thickness measurement, but the stem iron's width is the same as the stem. The stem is raked at an angle of 13 degrees, measured immediately above the bobstays. As the stem rises toward the bowsprit the stem gradually curves into the bow knee.
